**Name Of Dam:** UPPER BLACKWATER NO. 6  
**Location:** FRANKLIN COUNTY, VIRGINIA  
**Inventory Number:** 06701

# PHASE I INSPECTION REPORT NATIONAL DAM SAFETY PROGRAM

**PREPARED BY**  
**NORFOLK DISTRICT CORPS OF ENGINEERS**  
**803 FRONT STREET**  
**NORFOLK, VIRGINIA 23510**

AUGUST 1979

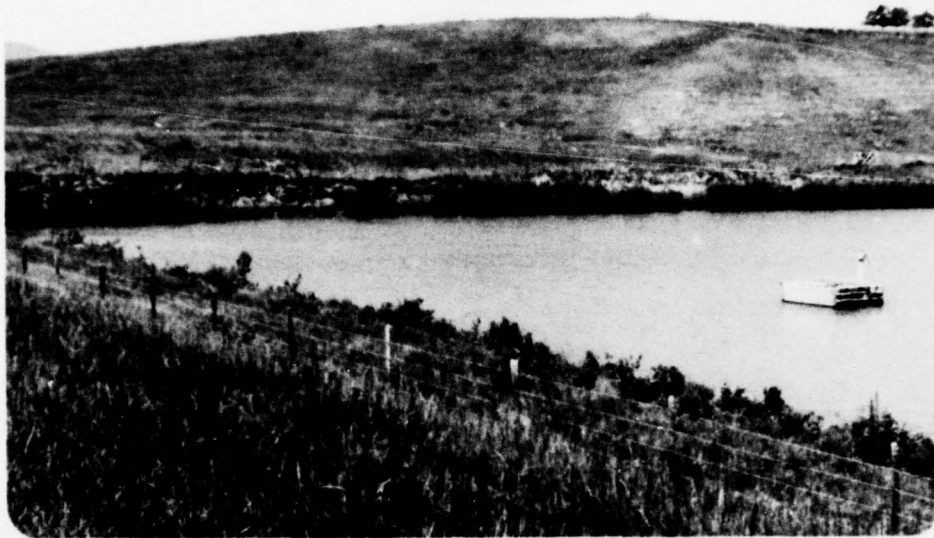
PHOTO # 1 INTAKE STRUCTURE

3.1.4 Appurtenant Structures: The intake structure was not inspected because the structure is only accessible by boat. Observing from a distance, a substantial amount of debris had accumulated at the trash rack. However, water was flowing into the intake structure since the 24-inch-diameter outlet pipe was discharging about 1/6 full. The outlet pipe and its concrete saddle were in excellent condition. The handle for the emergency gate located at the intake structure was not in place; it is stored at the landowners' premises.

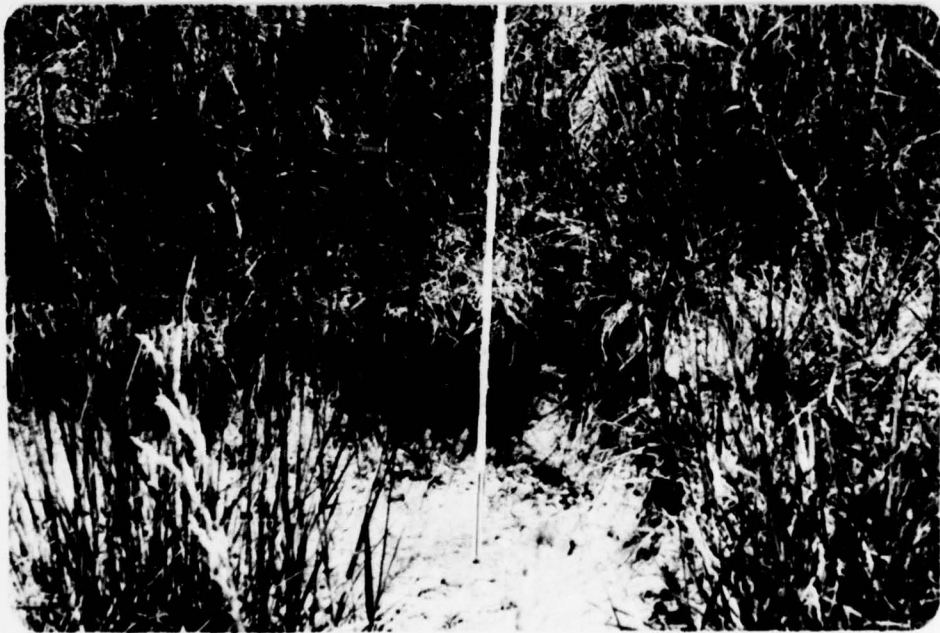
3.1.3 Junction of Embankment and Abutment: Minor erosion caused by runoff was observed at the lower section of the right junction of both the upstream and downstream slopes. Some bare spots were observed at the middle section of the right junction of the downstream slope.

PHOTO # 4 EROSION DOWNSTREAM SLOPE

b. All gullies caused by runoff should be filled with compacted soils of the same type forming the faces of dam. The restored areas should be seeded to form a good grass cover.

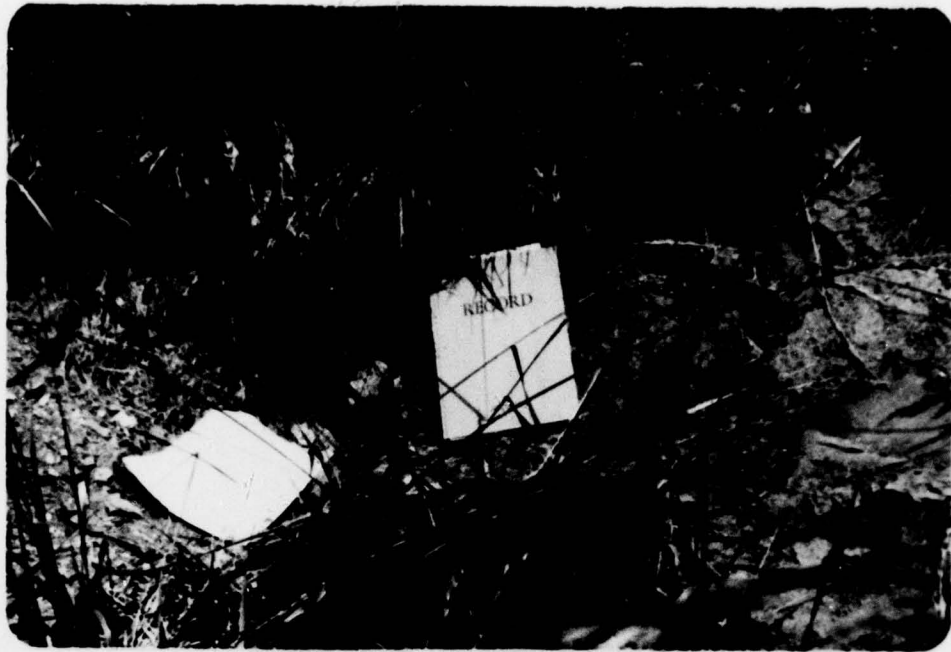
PHOTO # 5 EROSION DOWSTREAM SLOPE

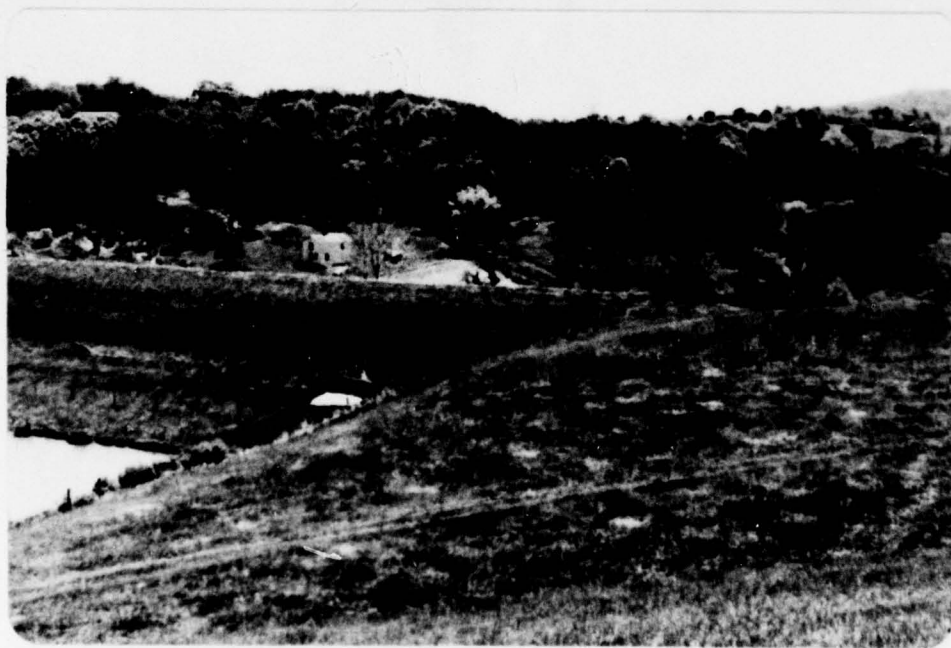
3.1.5. Emergency Spillway: All the spillway faces were covered with short grasses. The landowner used the entire area as cow pastures. The side slopes of the approach channel were steep and some minor sloughing was noted at the bare areas. Beyond the discharge channel (4 percent slope) the ground dipped into a steep slope which might present an erosion problem for the discharge channel should the emergency spillway operate.

PHOTO # 6 CONTACT RT. ABUTMENT / EMBANKMENT  
AND  
EMERGENCY SPILLWAY
